**CORROSION CONDITION SURVEY  
OF U1020 MONTANA AVENUE OVERPASS-BILLINGS  
FOR  
MONTANA DEPARTMENT OF TRANSPORTATION  
WJE No. 2000.2547  
November 27, 2000**

CORROSION CONDITION SURVEY  
OF U1020 MONTANA AVENUE OVERPASS-BILLINGS  
FOR  
MONTANA DEPARTMENT OF TRANSPORTATION  
WJE No. 2000.2547  
November 27, 2000

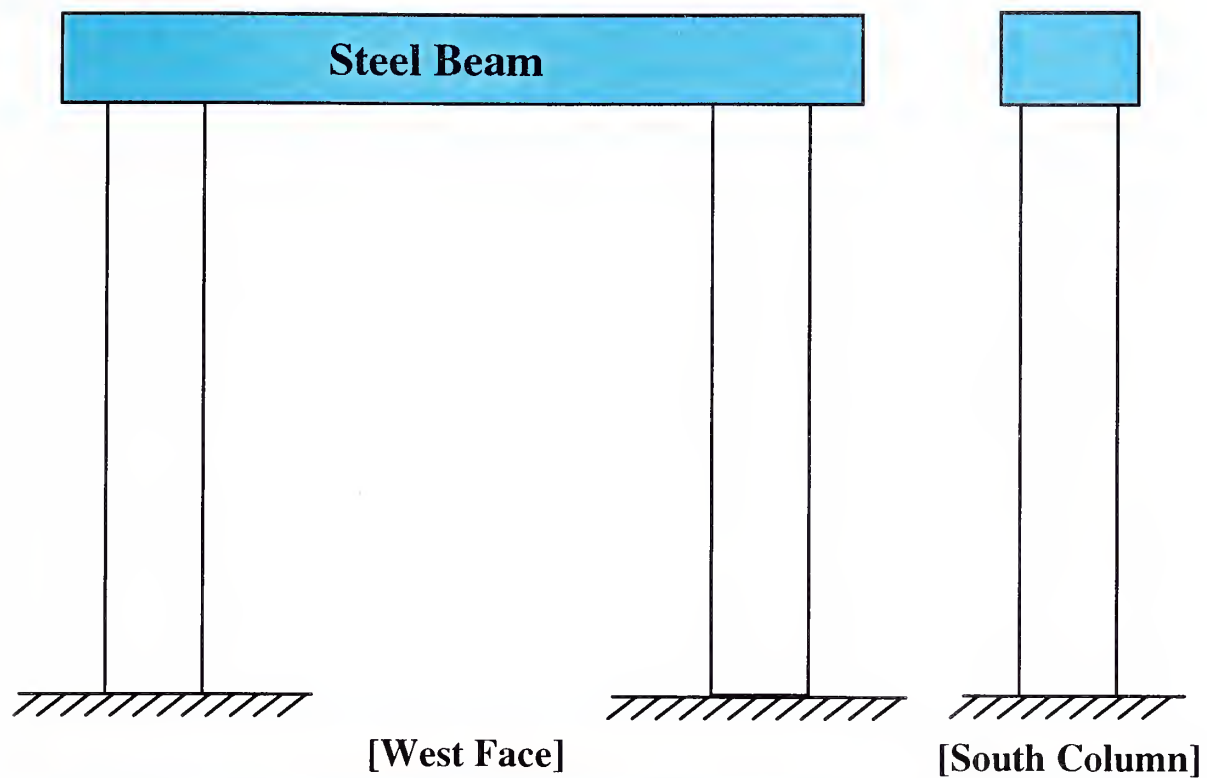
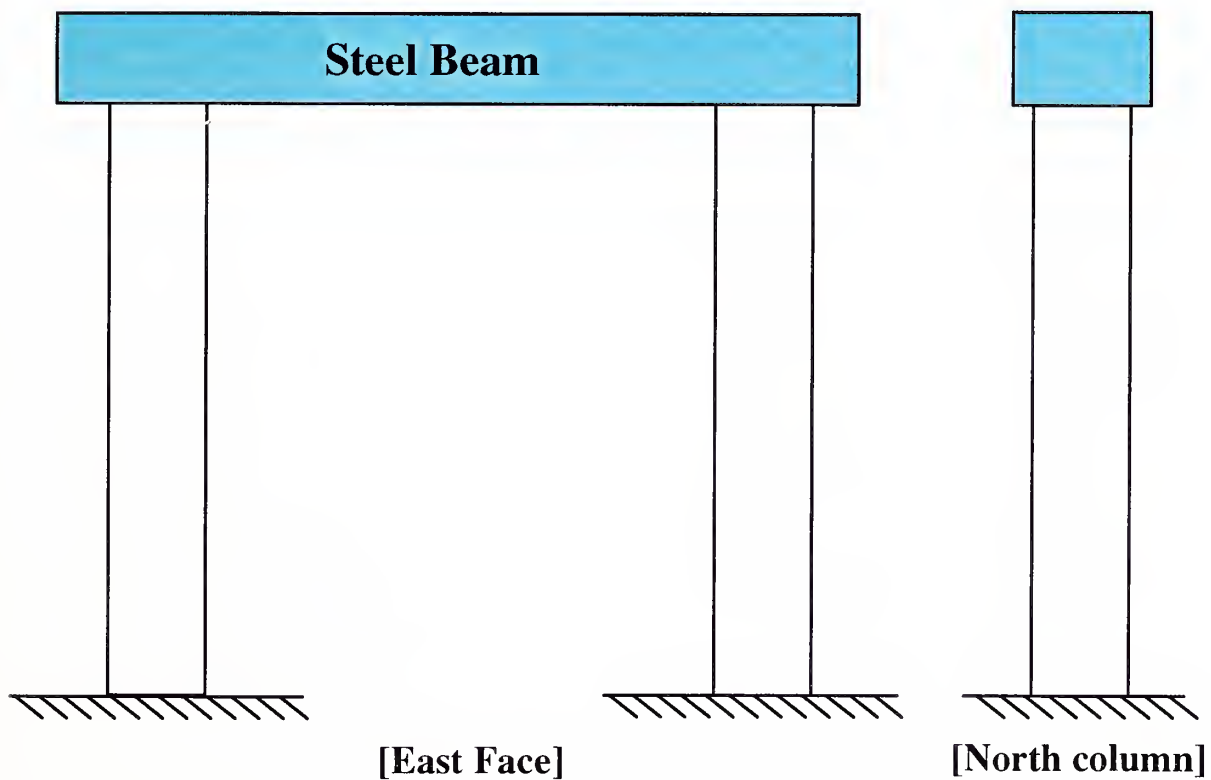
Figure 42A. Condition of Bent No. 12 (West Bound).

Damage	Location	Face	Description of Damage (No.)	Leakage Condition: No deck above and exposed  Test Performed: None
		No Damage Observed

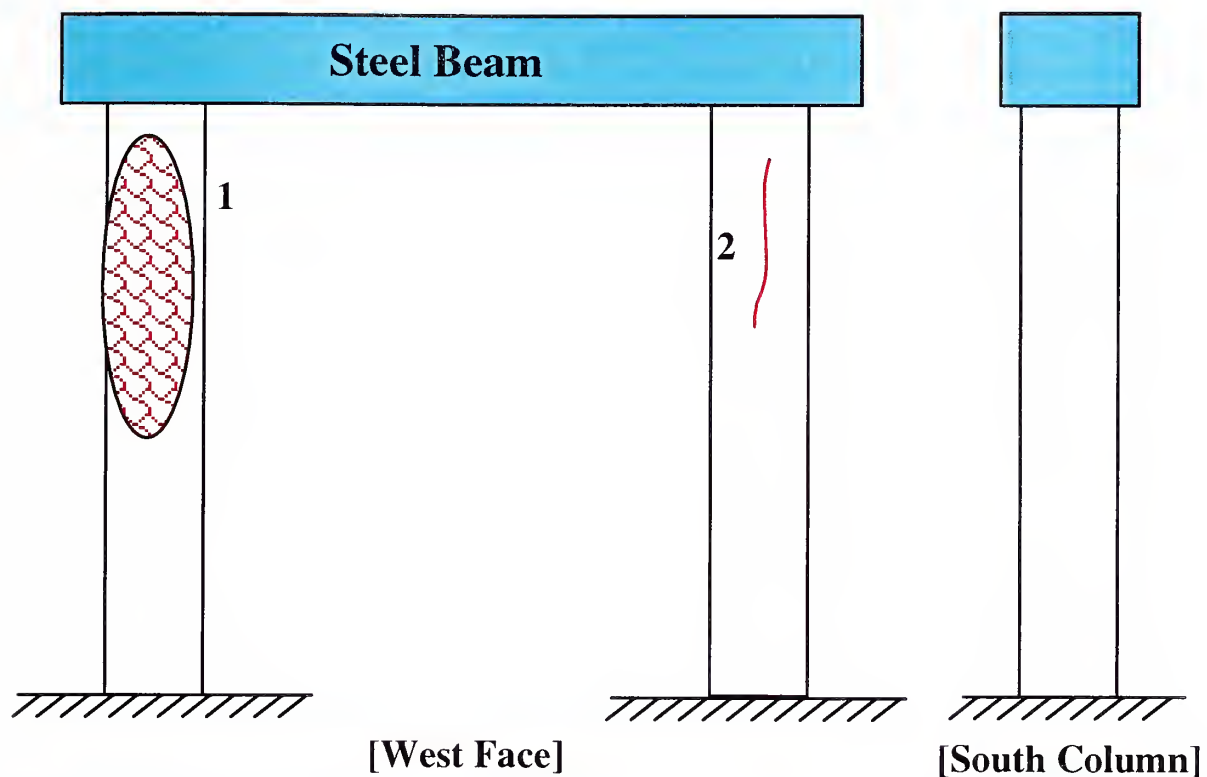
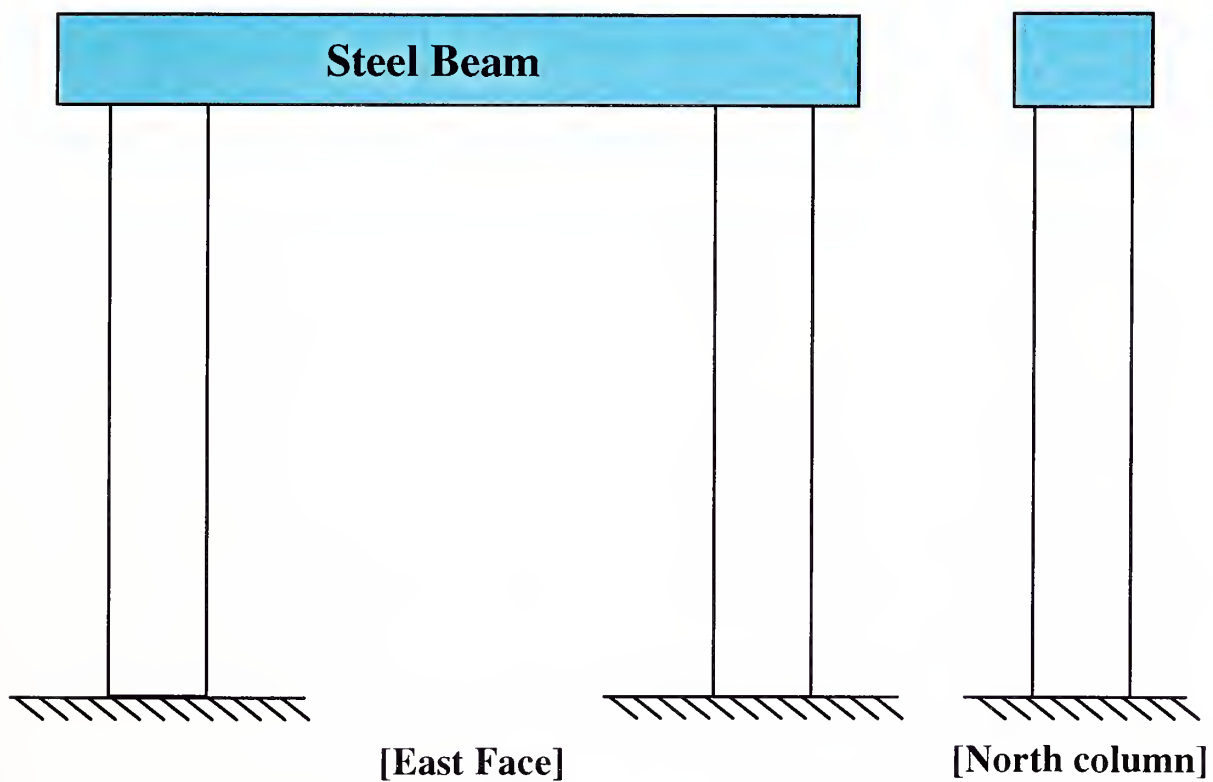
**Figure 43A. Condition of Bent No. 13 (West Bound).**

Damage	Location	Face	Description of Damage (No.)	Leakage Condition: No deck above and exposed
	Column	West	Pattern cracking (1)	
	Column	West	A crack (2)	
				Test Performed: None

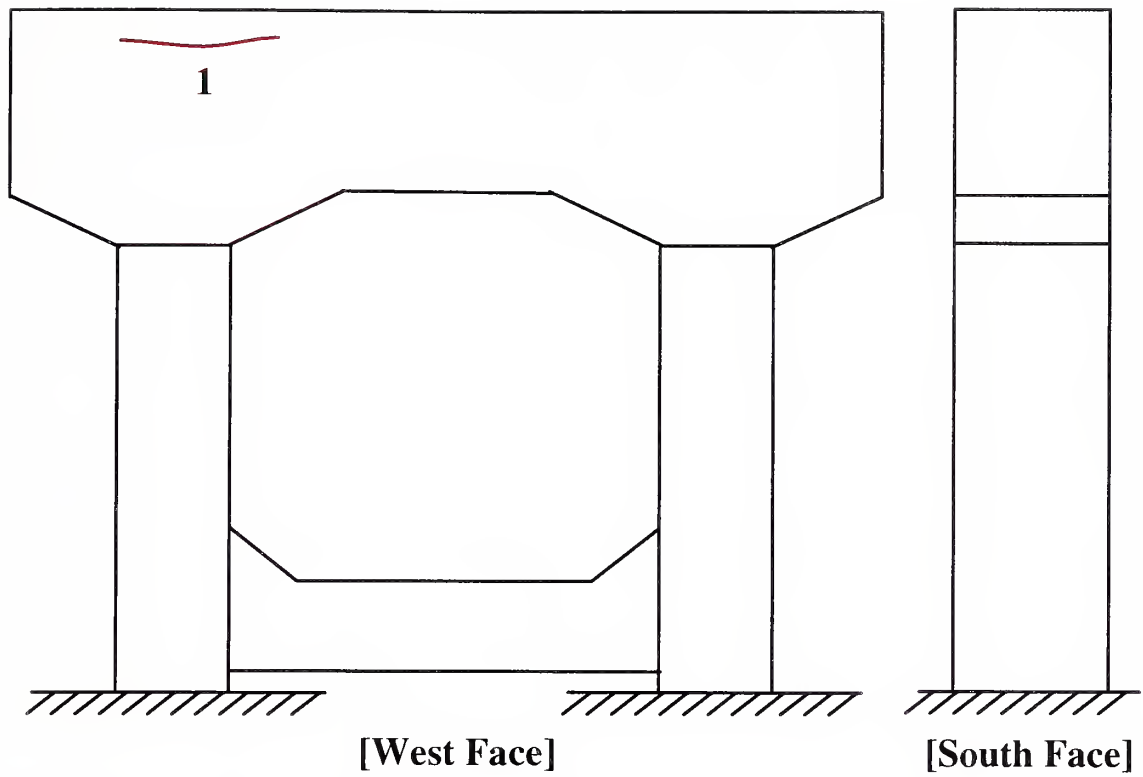
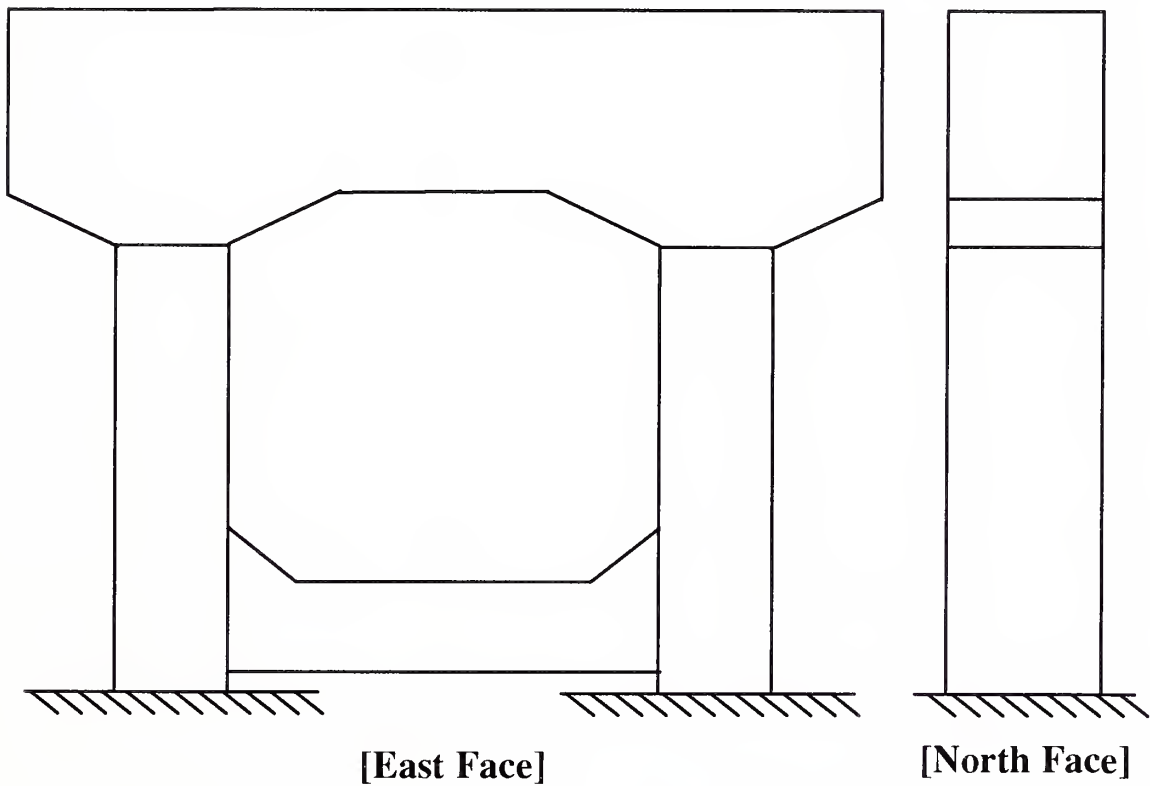
Figure 44A. Condition of Bent No. 14 (West Bound).

Damage	Location	Face	Description of Damage (No.)	Leakage Condition: No Leakage
	Cap	West	A crack (1)	
				Test Performed: None

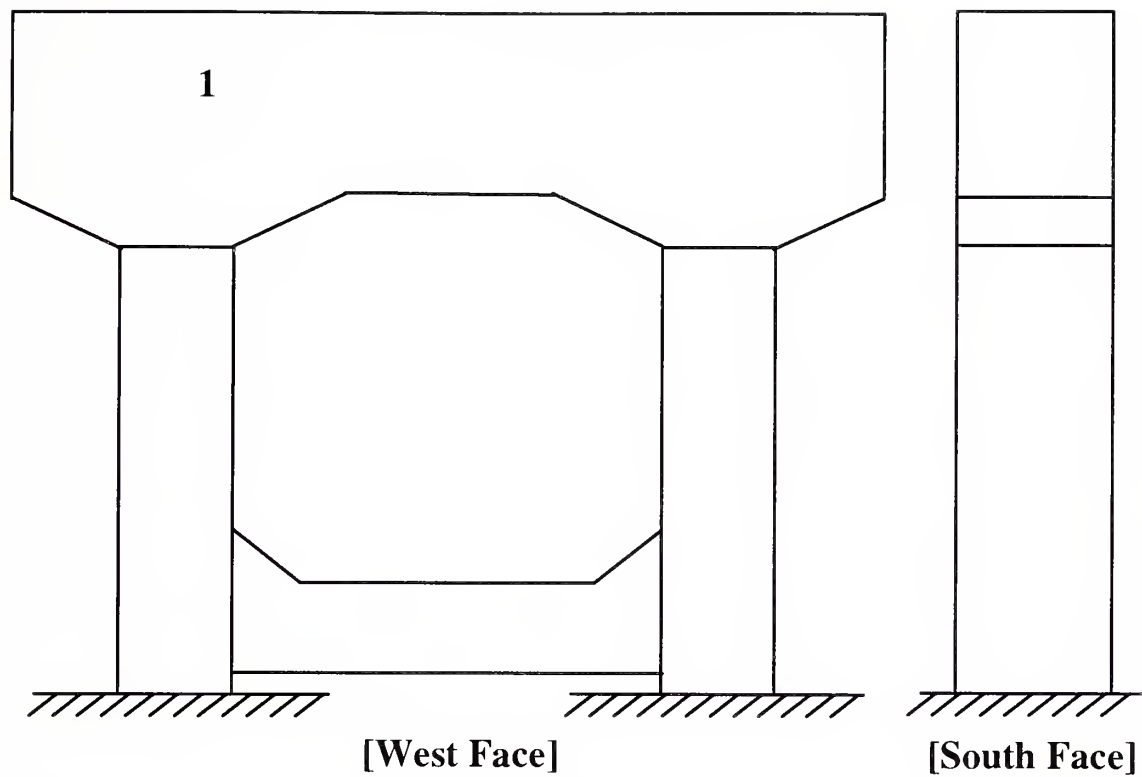
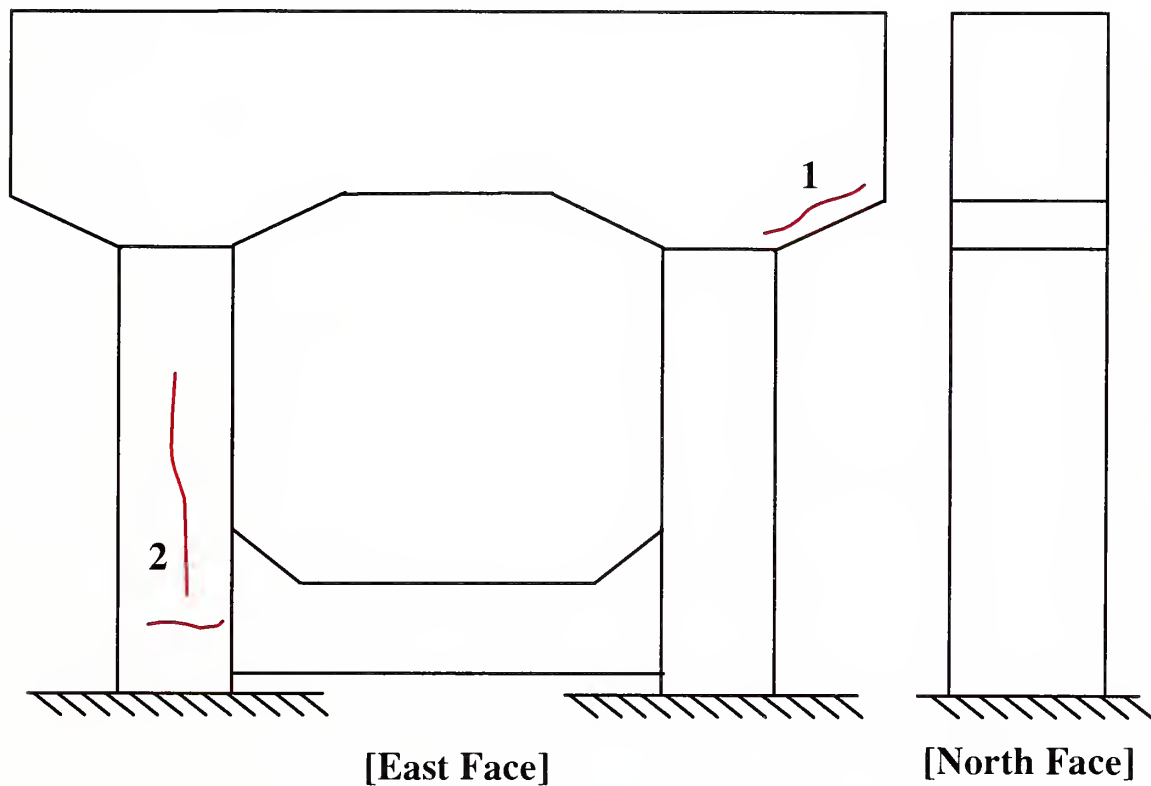
Figure 45A. Condition of Bent No. 15 (West Bound).

Damage	Location	Face	Description of Damage (No.)	Leakage Condition: Active leakage below beams 3-4, 4-5 and moist below beams 2-3 Test Performed: None
	Cap	East	A crack along the edge (1)	
	S. Col.	East	Two cracks (2)

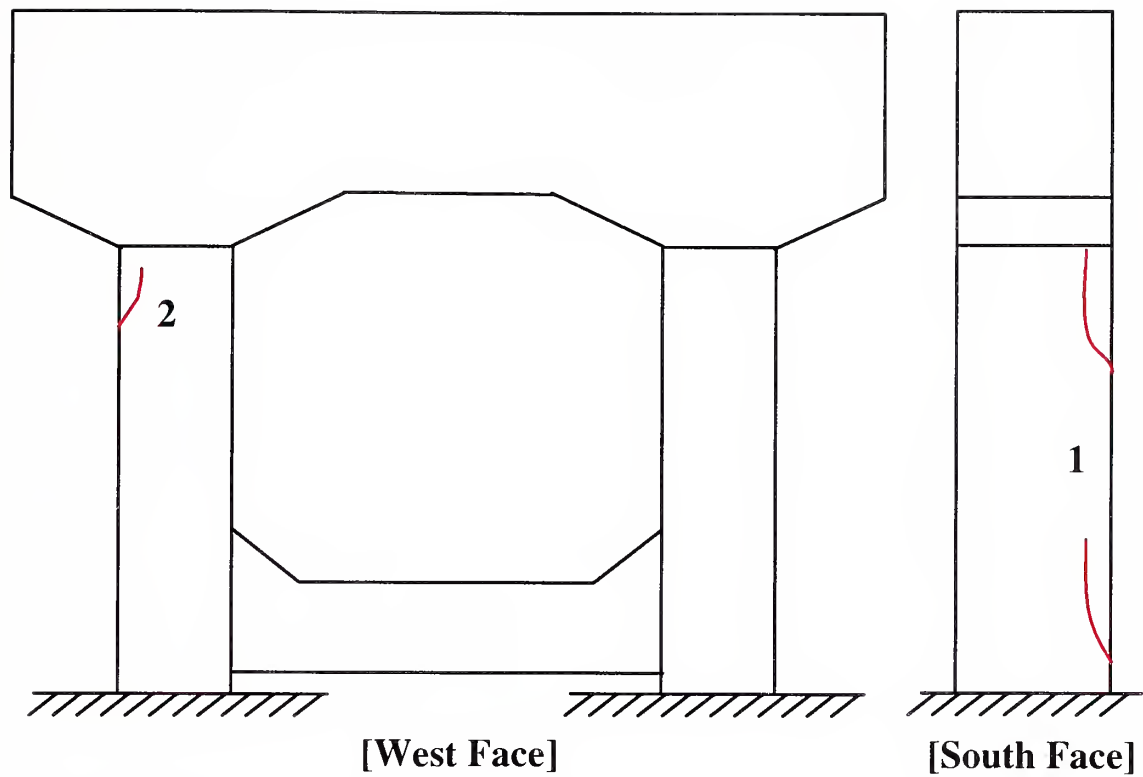
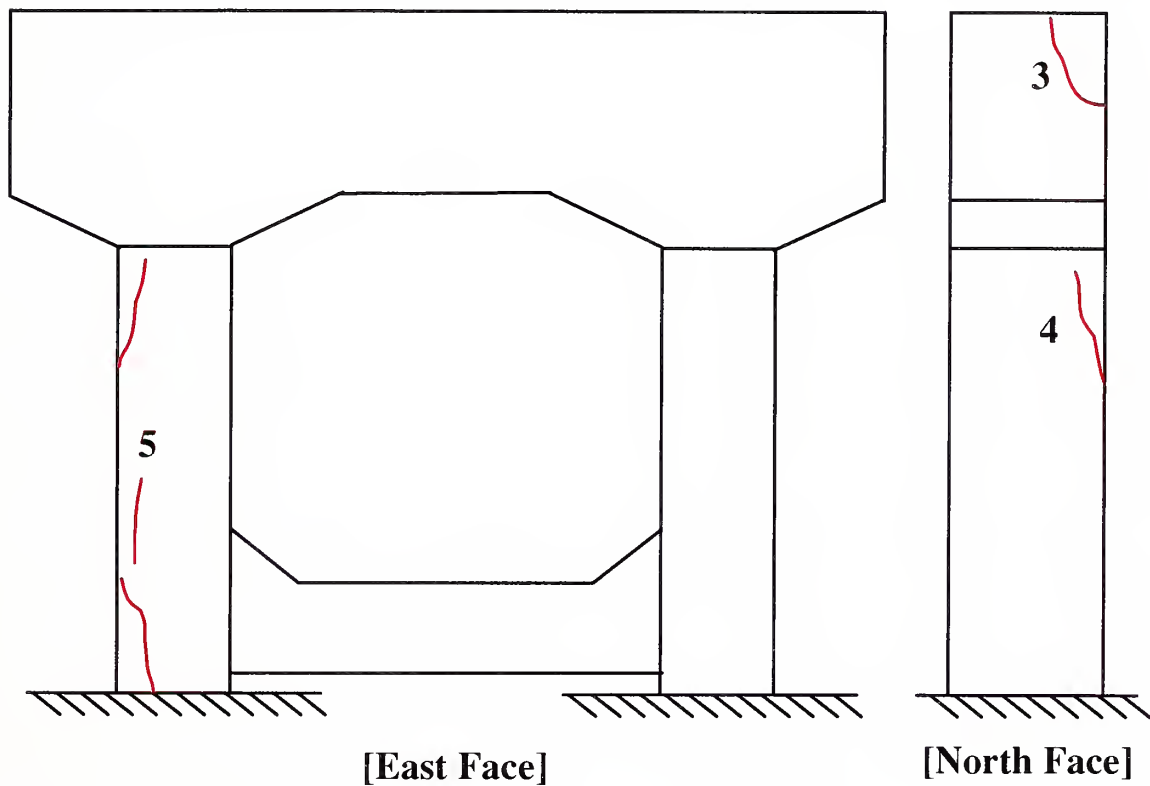
**Figure 46A. Condition of Bent No. 16 (West Bound).**

Damage	Location	Face	Description of Damage (No.)	Leakage Condition: No Leakage
	S. Col.	South	Two cracks (1)	
	N. Col.	West	A crack (2)	Test Performed: None
	Cap	West	A crack (3)	
	N. Col.	North	A crack (4)	
	S. Col.	East	Three cracks (5)

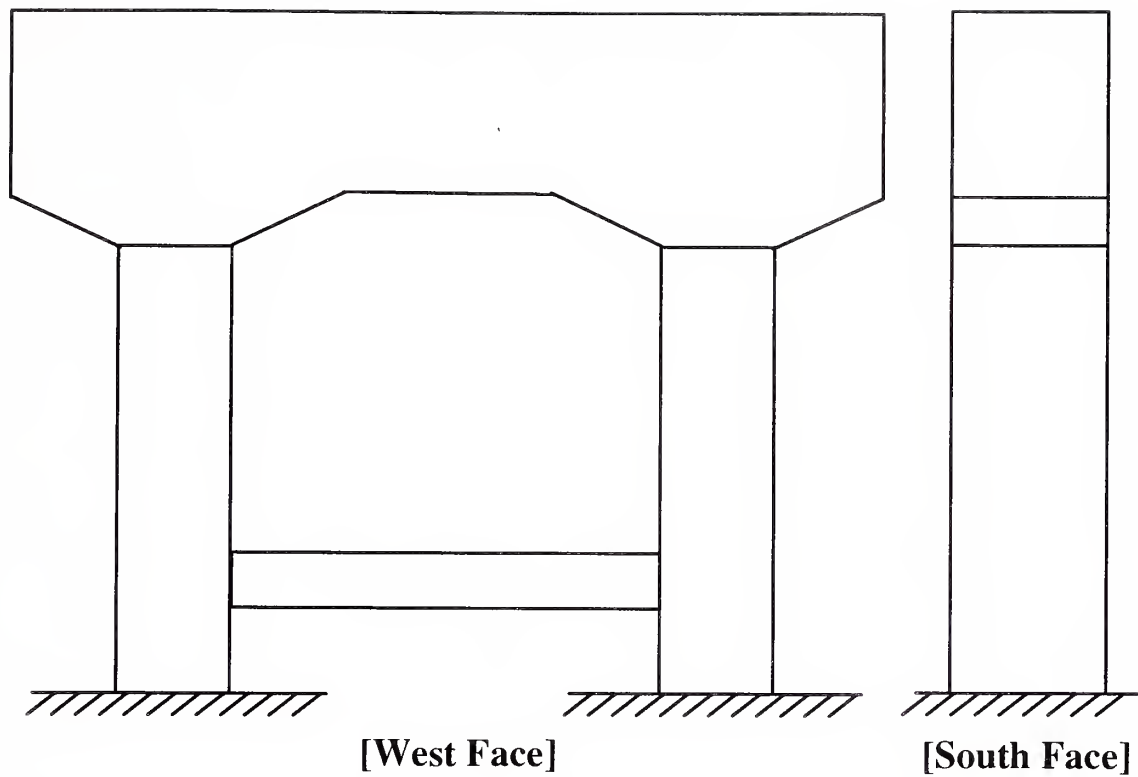
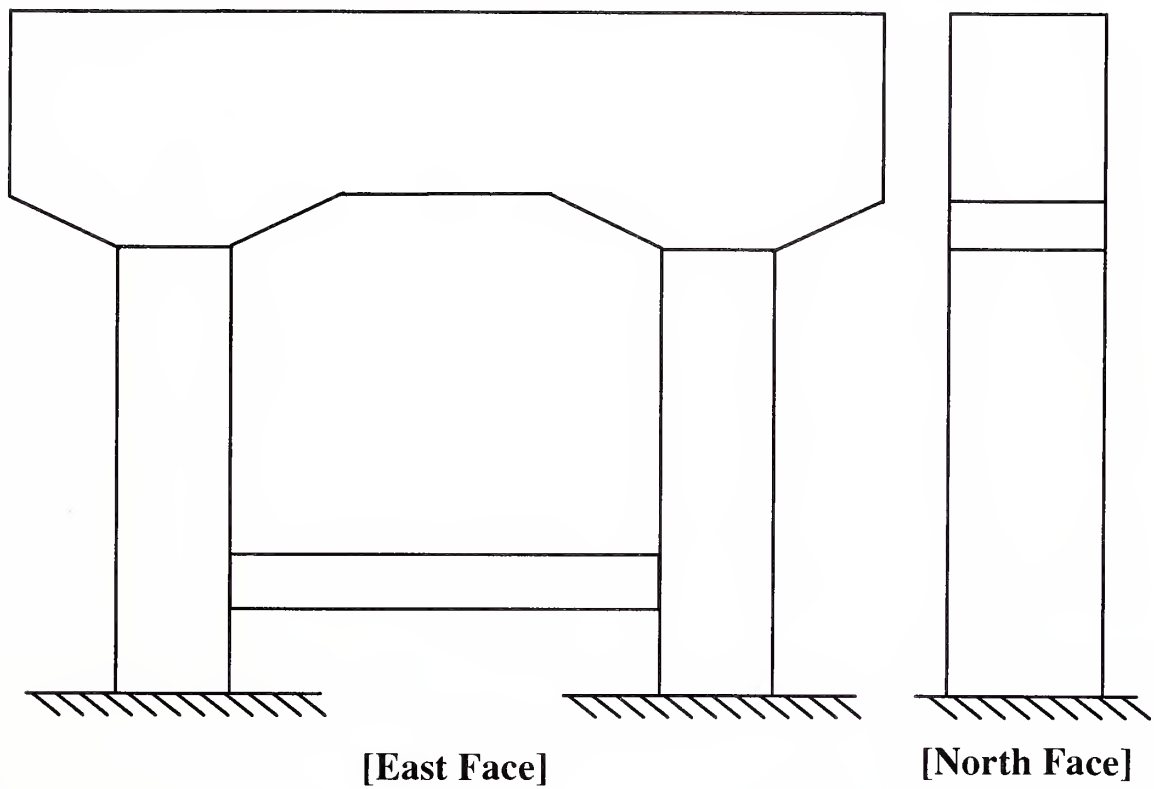
Figure 48A. Condition of Bent No. 18 (West Bound).

Damage	Location	Face	Description of Damage (No.)	Leakage Condition:
				No Leakage
		No Damage Observed		Test Performed: None

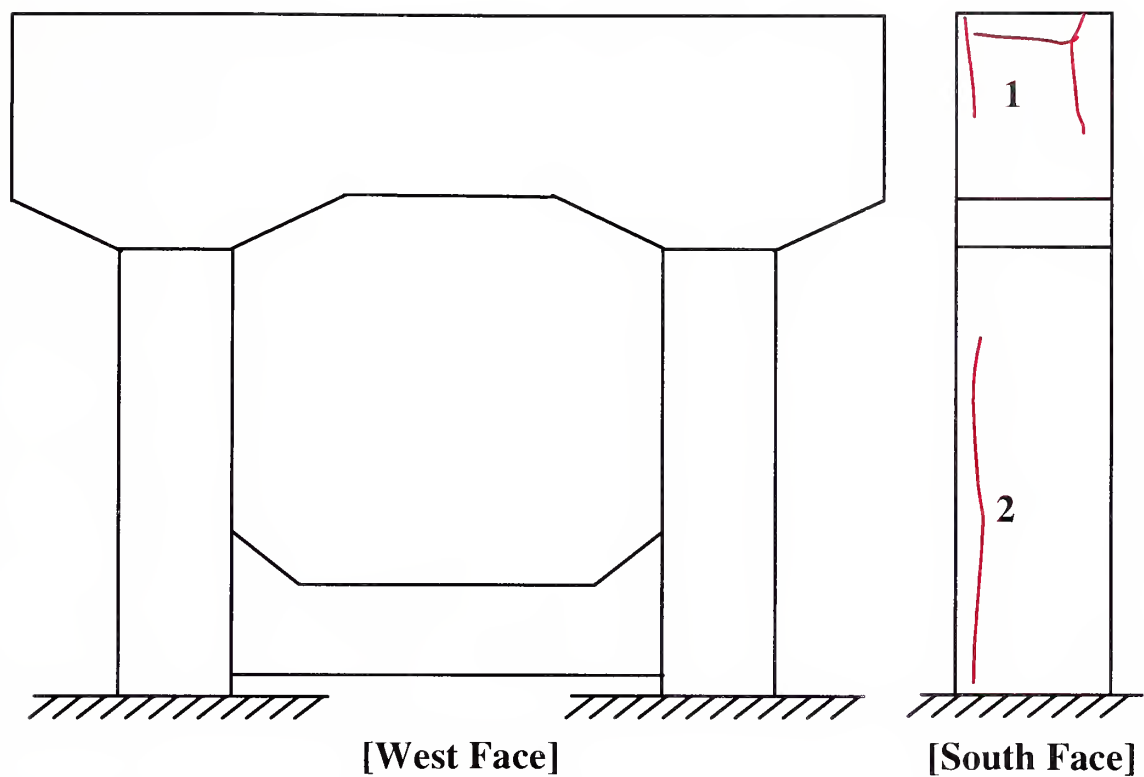
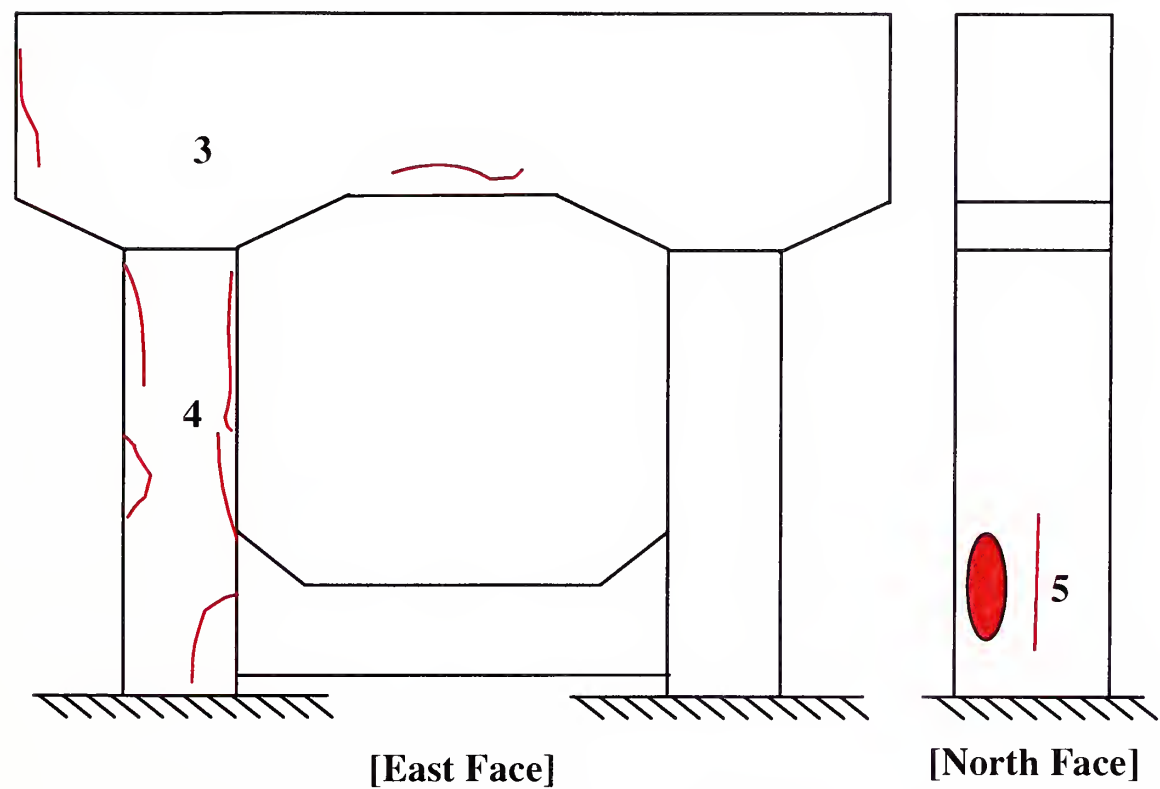
**Figure 49A. Condition of Bent No. 19 (West Bound).**

Damage	Location	Face	Description of Damage (No.)	Leakage Condition: Very active leakage below beams 4-5 and wet below beams 3-4 Test Performed: None
	Cap	South	Three cracks (1)	
	S. Col.	South	A crack (2)	
	Cap	East	Two cracks (3)	
	S. Col.	East	Five cracks(4)	
	N. Col.	North	Spall and a crack (5)

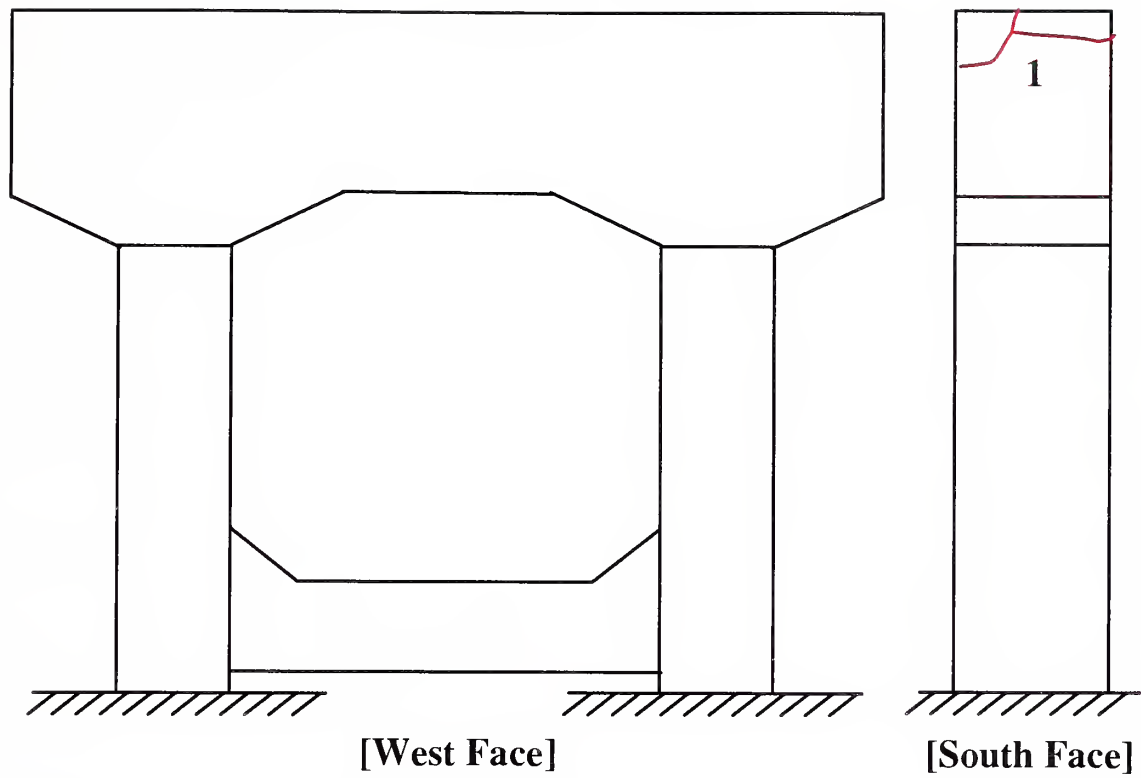
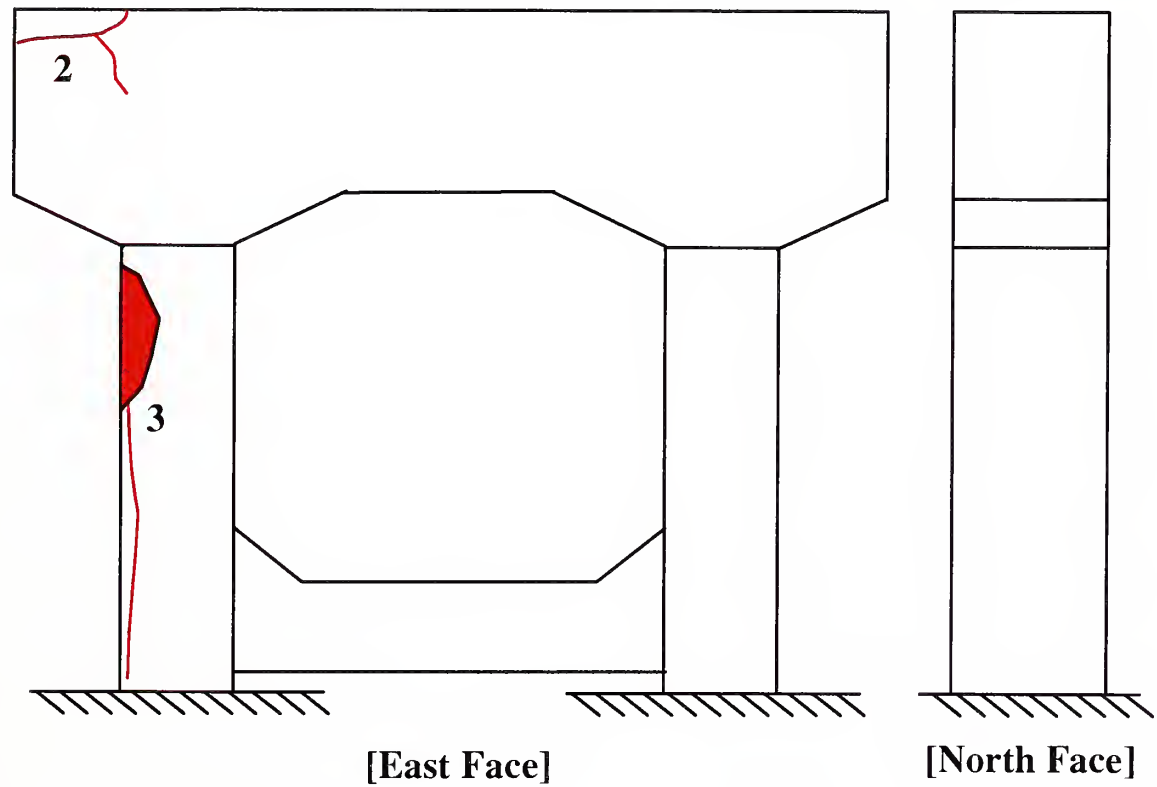
Figure 51A. Condition of Bent No. 21 (West Bound).

Damage	Location	Face	Description of Damage (No.)	Leakage Condition: Wet below beams 4-5 and moist below 3-4  Test Performed: None
	Cap	South	Two cracks (1)	
	Cap	East	Two cracks (2)	
	S. Col.	East	Spall and a crack along edge (3)

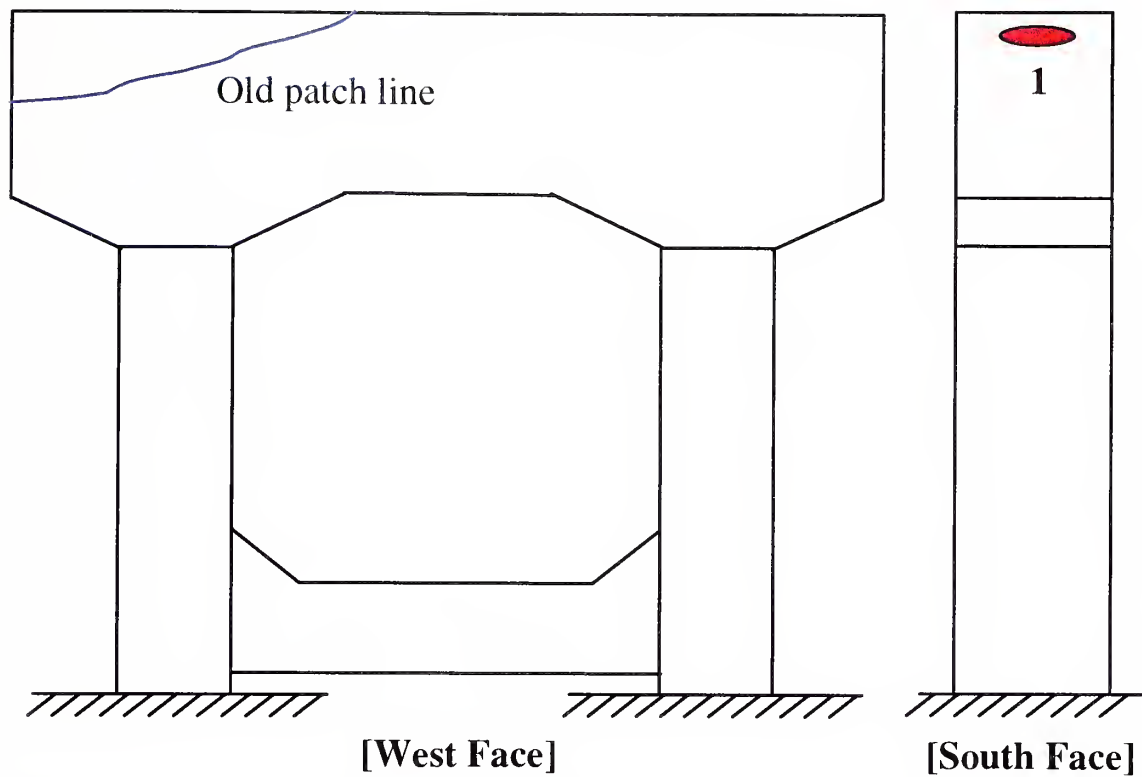
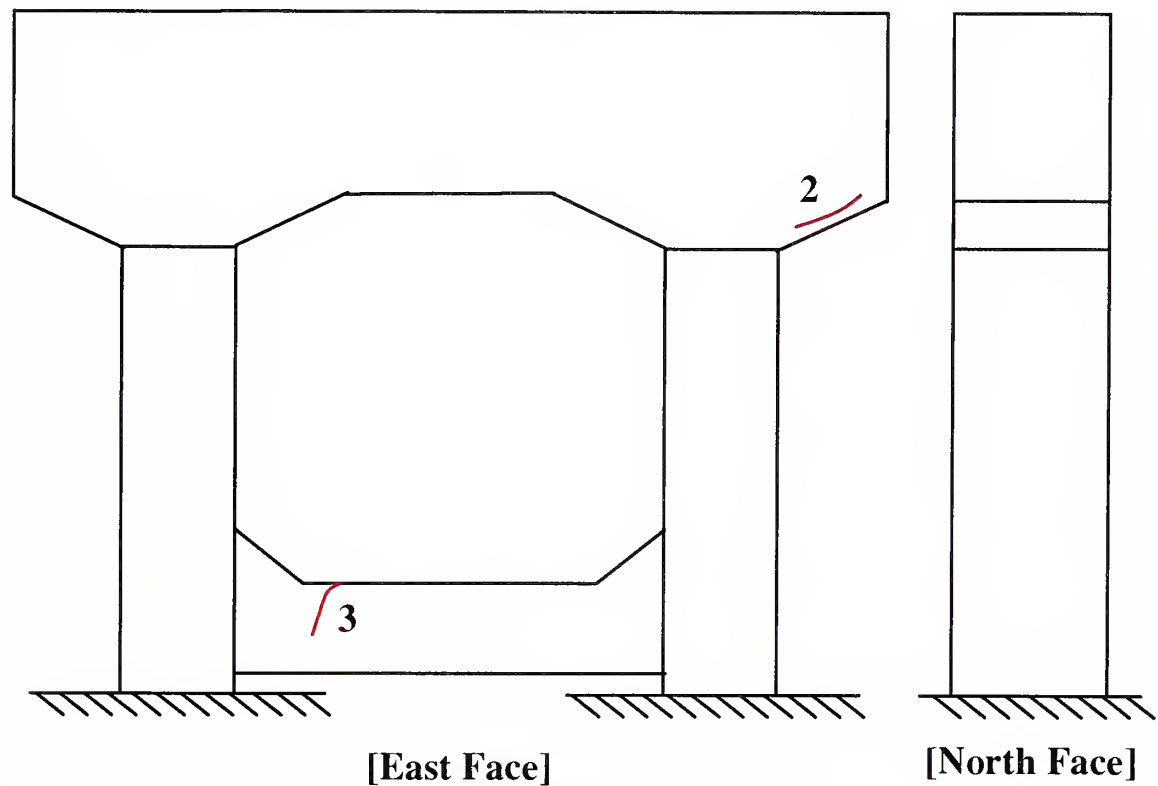
Figure 52A. Condition of Bent No. 22 (West Bound).

Damage	Location	Face	Description of Damage (No.)	Leakage Condition: No Leakage
	Cap	South	Small spall (1)	
	Cap	East	A crack (2)	
	Beam	East	A crack (3)	Test Performed: None

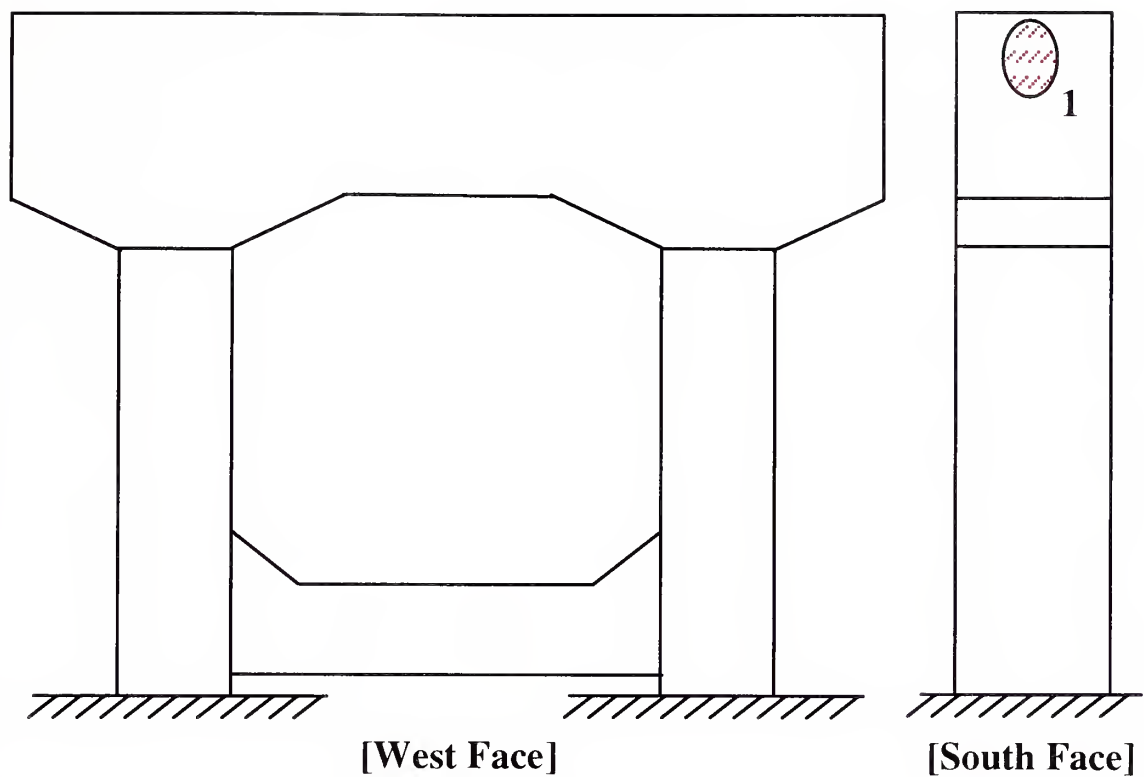
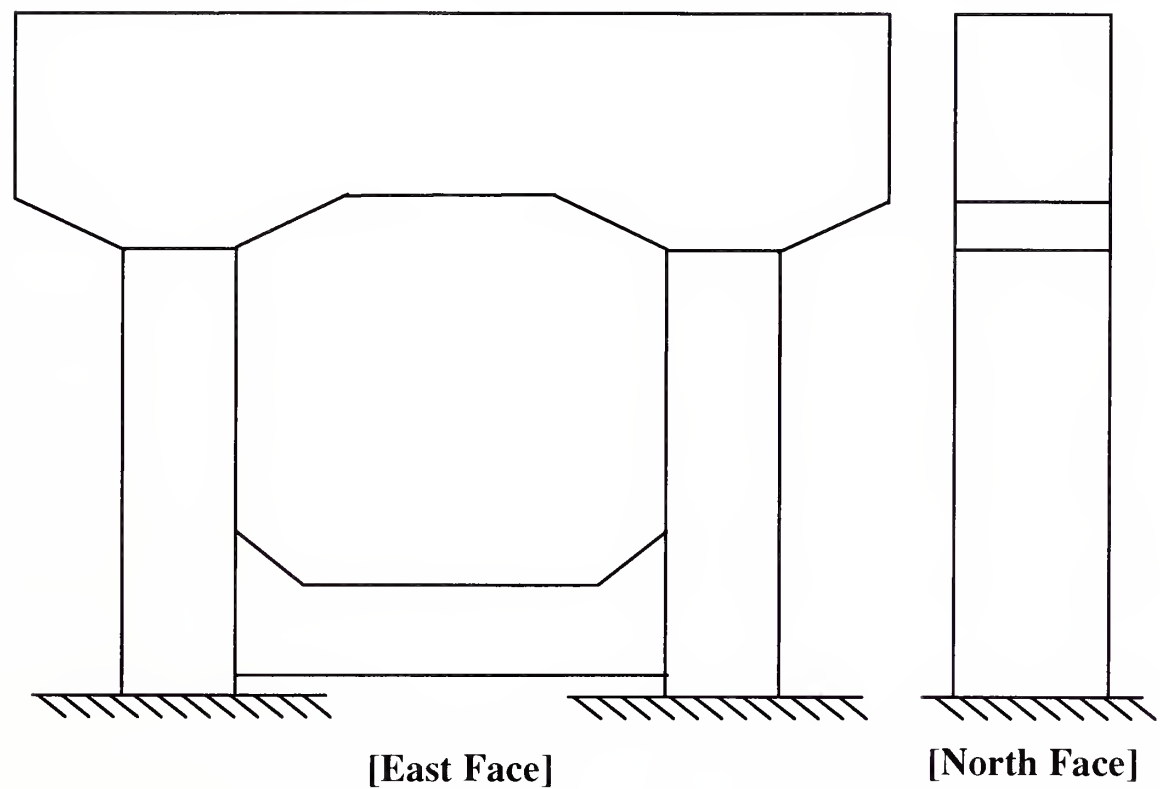
Damage	Location	Face	Description of Damage (No.)	Leakage Condition: Active leakage below beams 3-5 and dry stains Test Performed: None
	Cap	South	Multiple cracks (1)

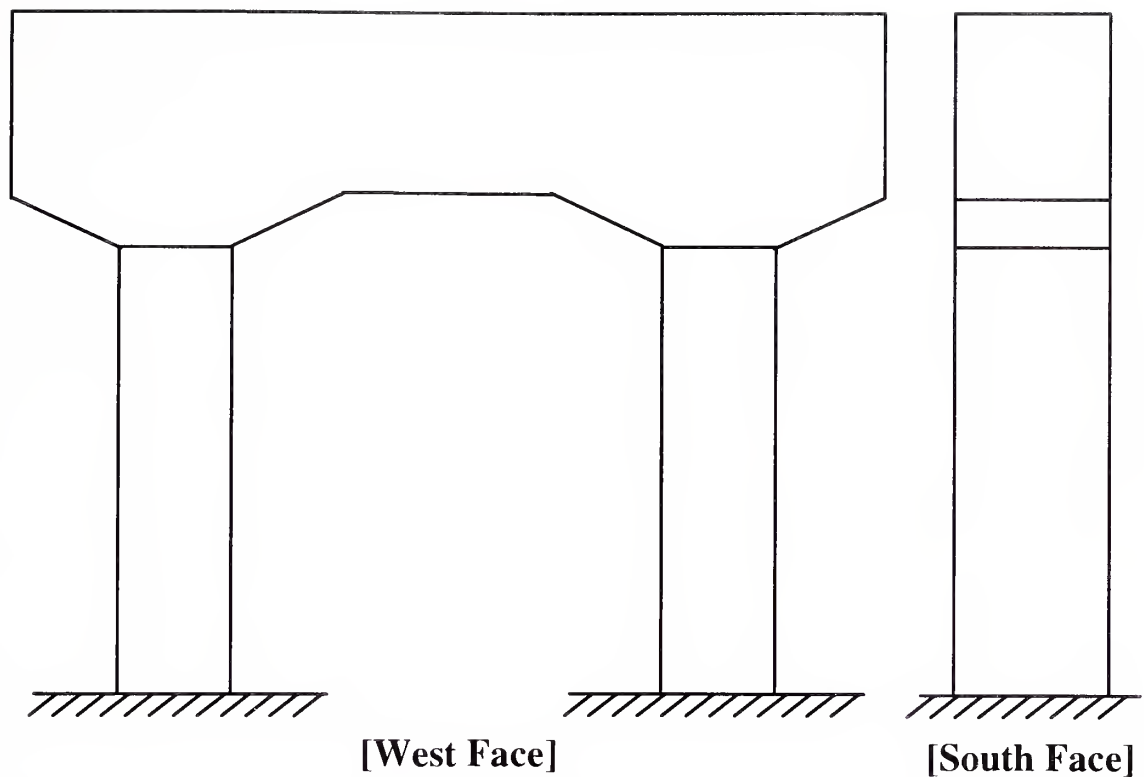
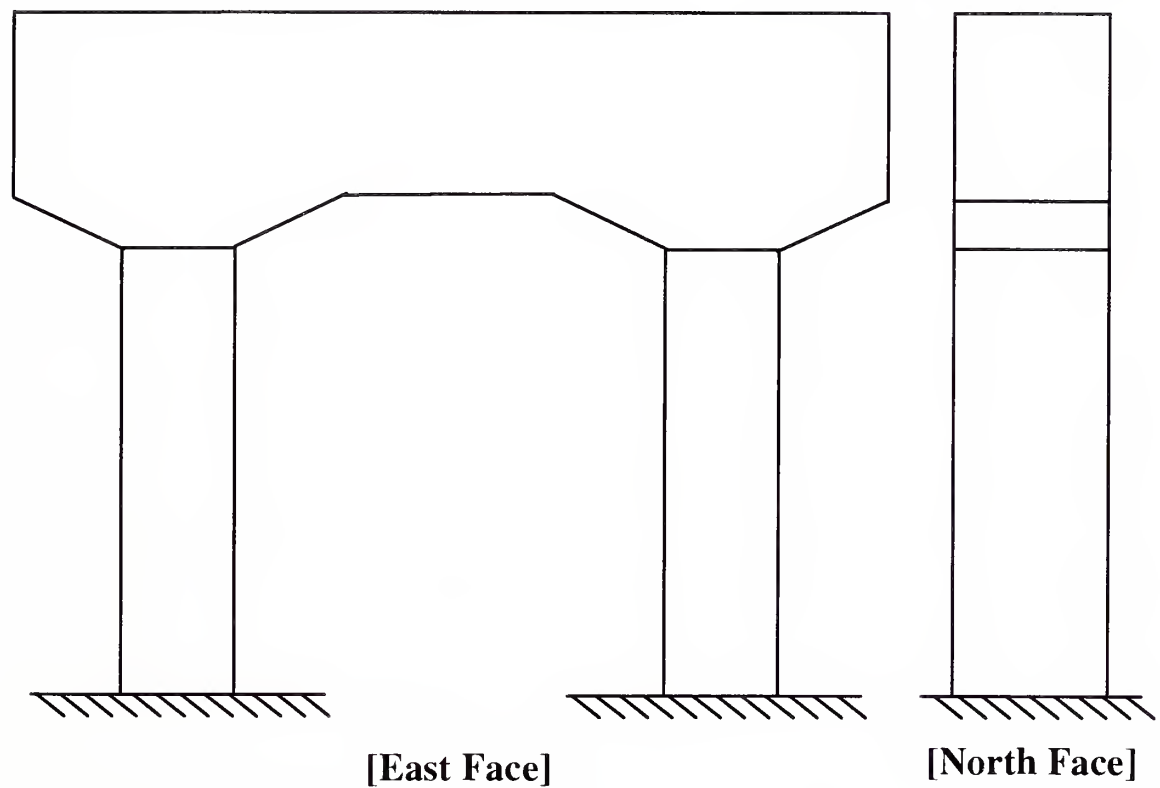
Figure 53A. Condition of Bent No. 23 (West Bound).

Damage	Location	Face	Description of Damage (No.)	Leakage Condition: No leakage but dry stains  Test Performed: None
			No Damage Observed

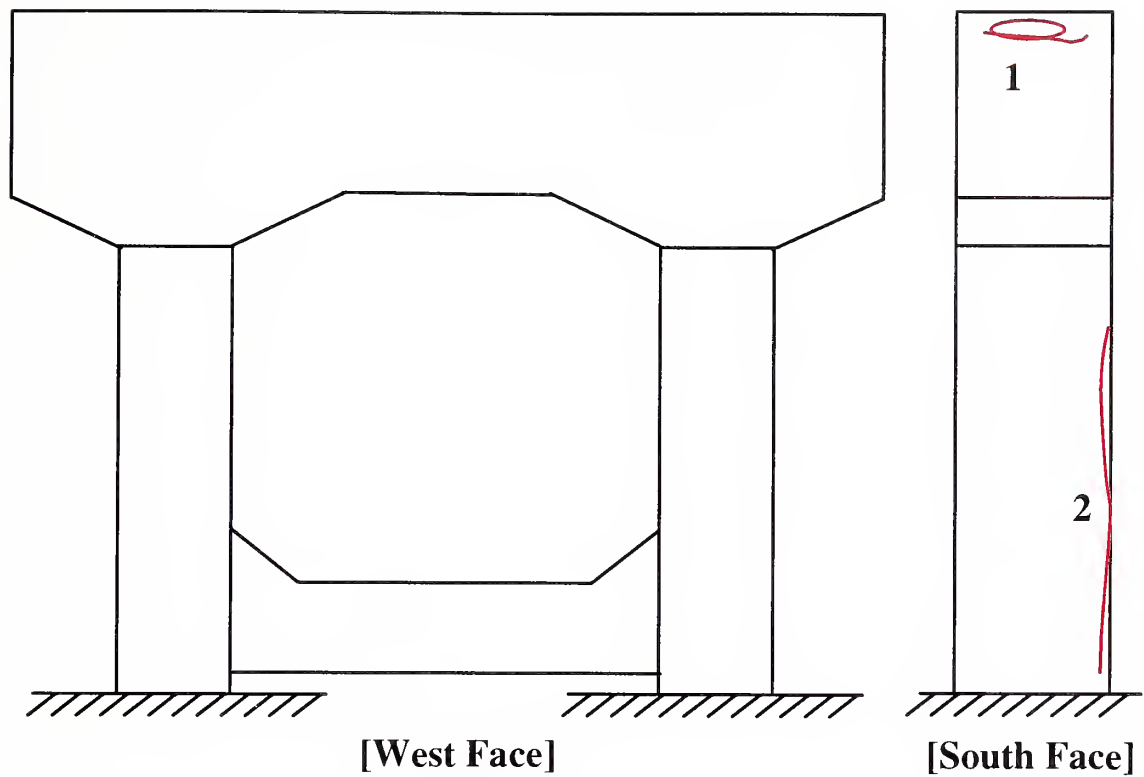
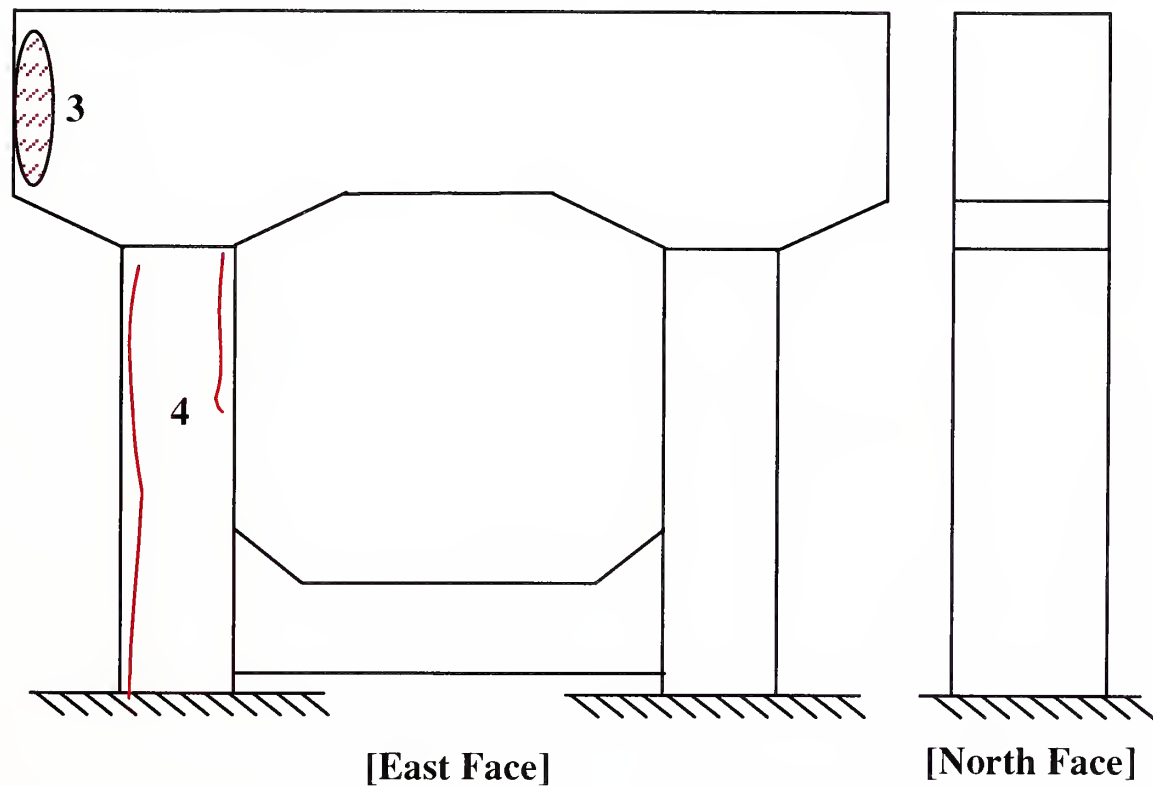
Figure 54A. Condition of Bent No. 24 (West Bound).

Damage	Location	Face	Description of Damage (No.)	Leakage Condition: Joint moist and south column wet due to a drainage pipe nearby Test Performed: None
	Cap	South	Delamination and a crack (1)	
	S. Col.	South	A crack (2)	
	Cap	East	Multiple cracks (3)	
	S. Col.	East	Two cracks(4)
